INVESTIGATION OF
SOIL CONTAMINATION
AS A RESULT OF
AN ALLEGED DISCHARGE
OF LEAD-ACID BATTERY SOLUTION
AT ERIE BATTERY INC.,
PORT COLBOURNE, 1991

FEBRUARY 1992

ARB-085-91-PHYTO

William I. Gizyn
Phytoxicology Section
Air Resources Branch
Ontario Ministry of the Environment

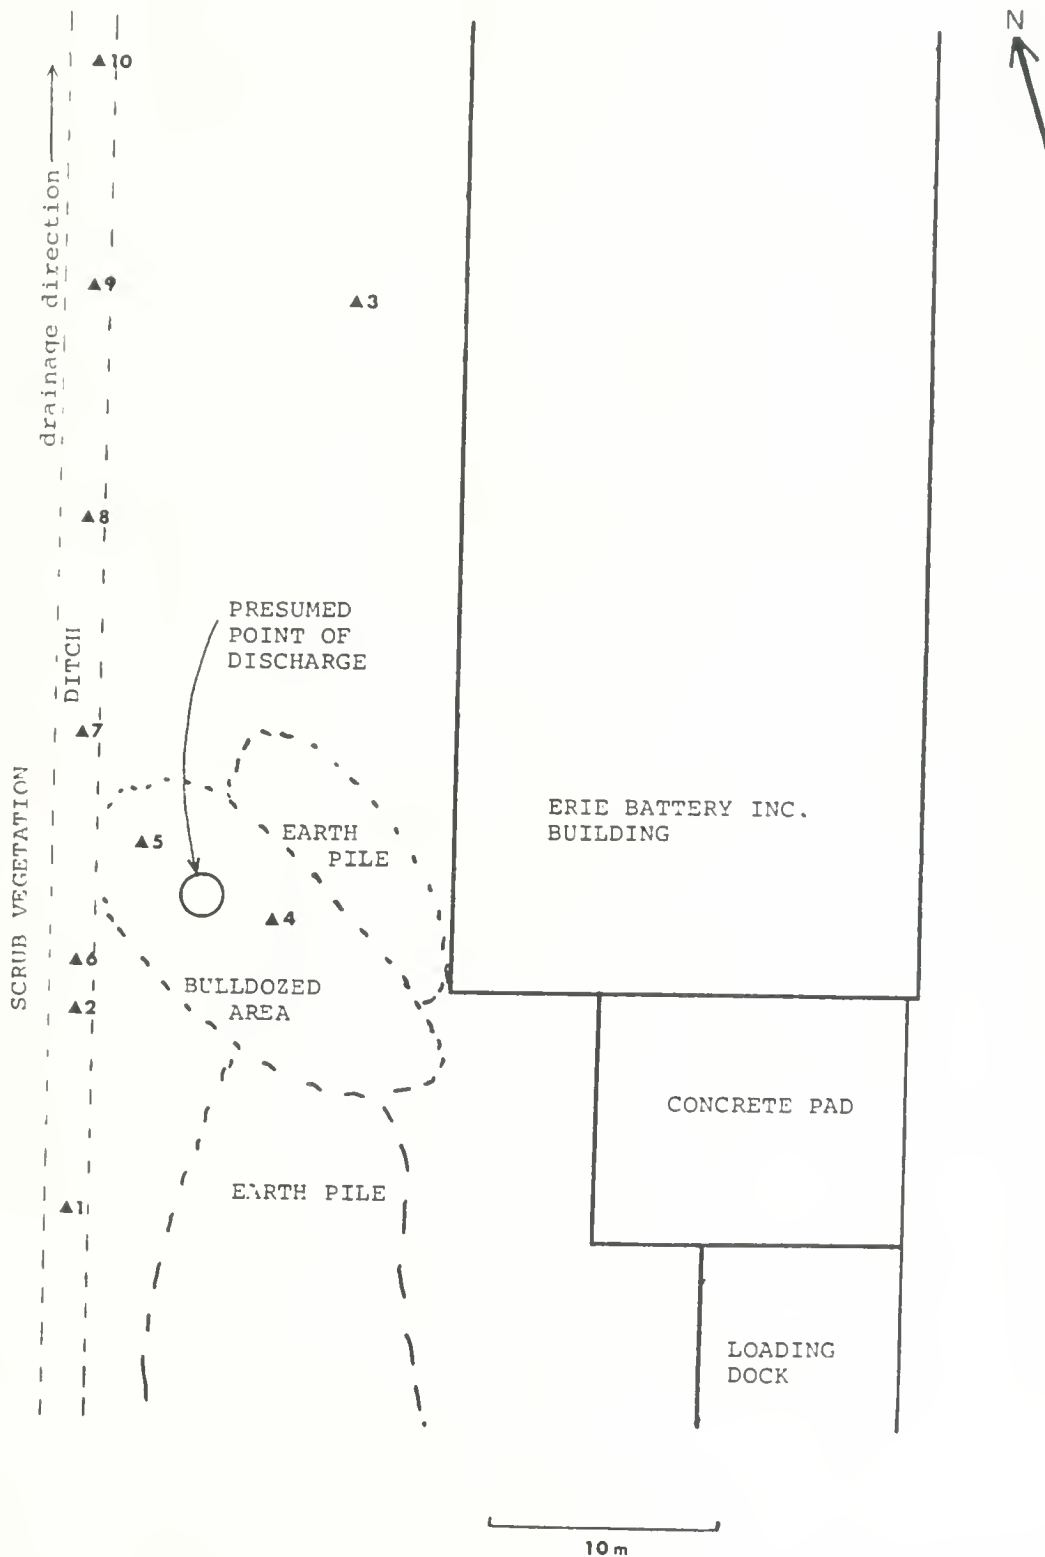
FIGURE 1: SKETCH MAP SHOWING THE LOCATION OF SOIL SAMPLING SITES
AT ERIE BATTERY INC., MAY 8, 1991

The whole area is relatively flat, with micro-drainage patterns that were mechanically created. Immediately east of this shrub area is a very shallow ditch (no more than 20 centimetres deep). Drainage from the west part of the Erie Battery property would be to the north, along this shallow ditch. Between the south end of the building and the ditch, there was evidence of soil disturbance. An earth pile approximately one metre high, and low, bulldozed areas devoid of any vegetation, were present. These landscape characteristics are illustrated in Figure 1.

The locations of the sample sites are indicated in Figure 1. Table 1 lists the sites, describes the site and its location, and presents the rationale for sampling at that point.

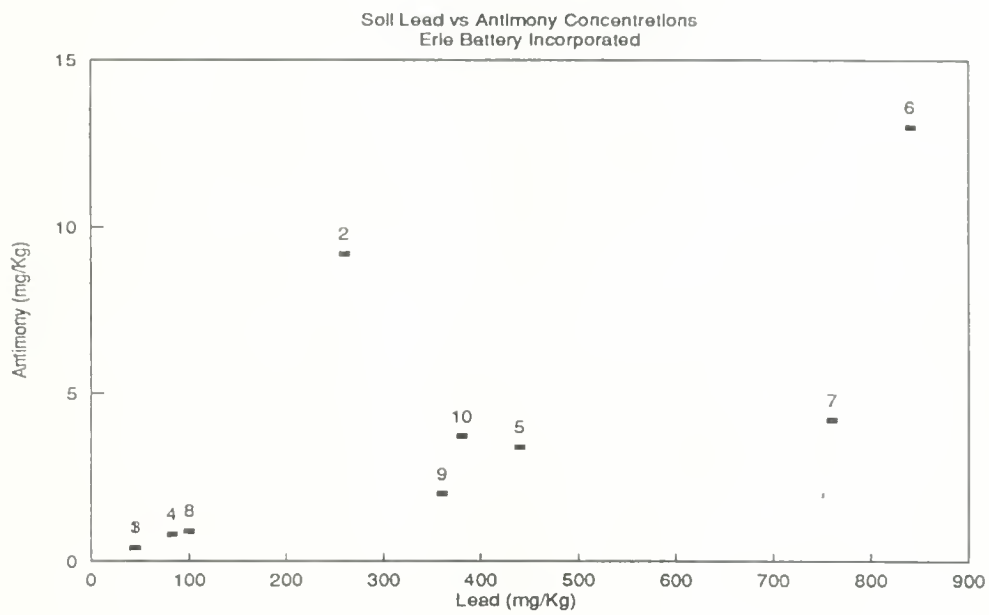
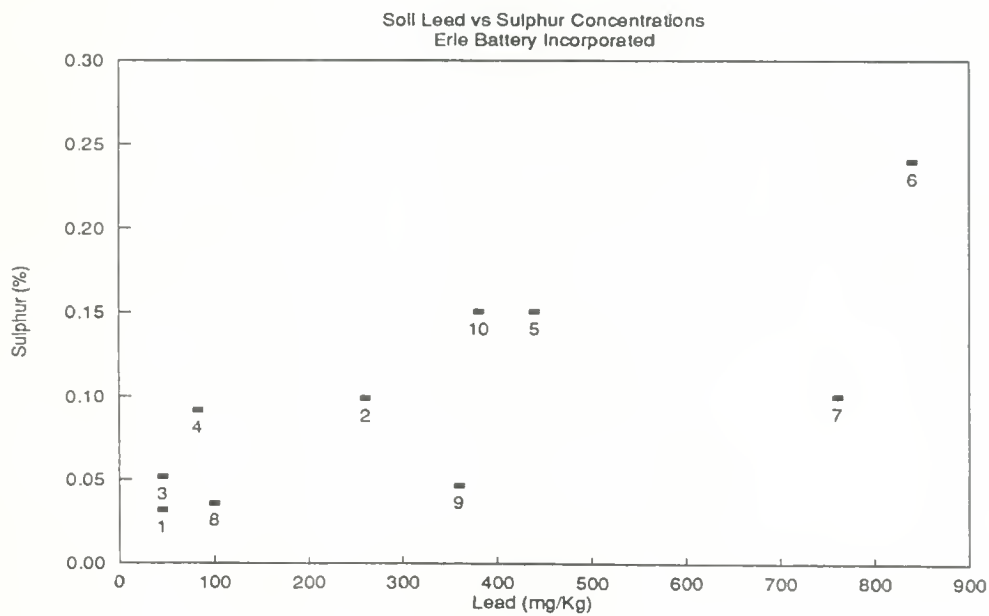
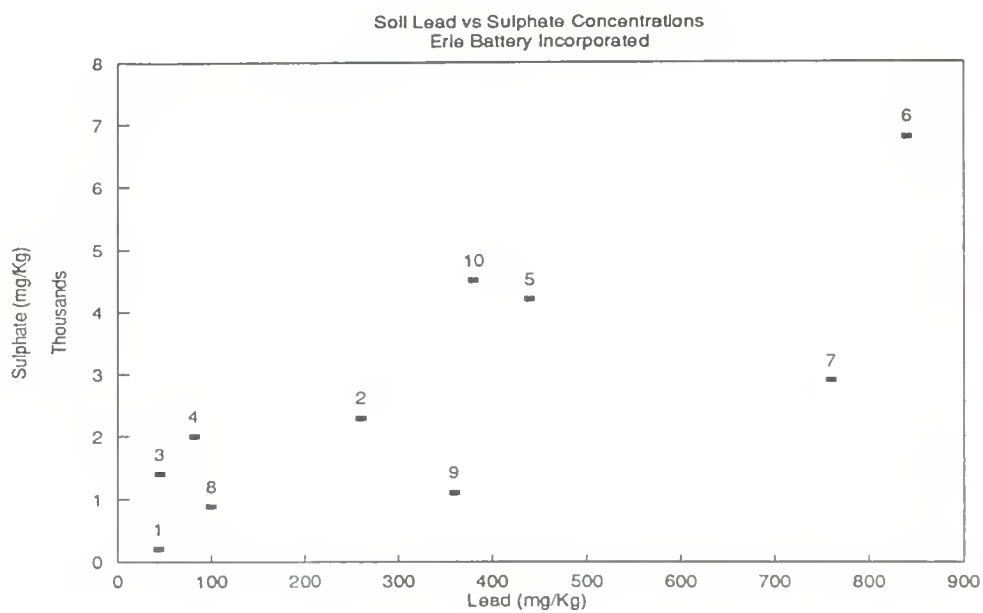
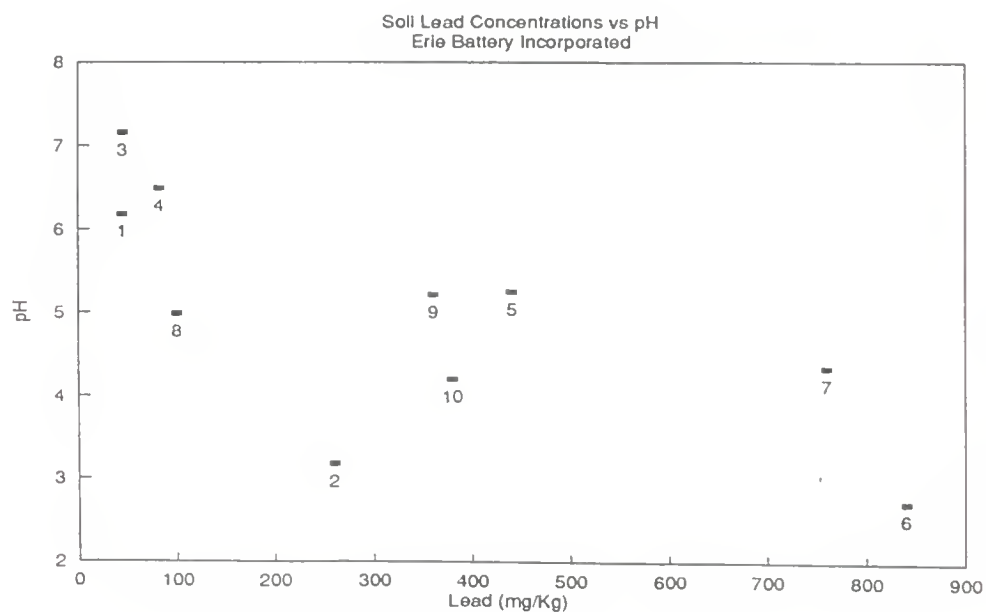
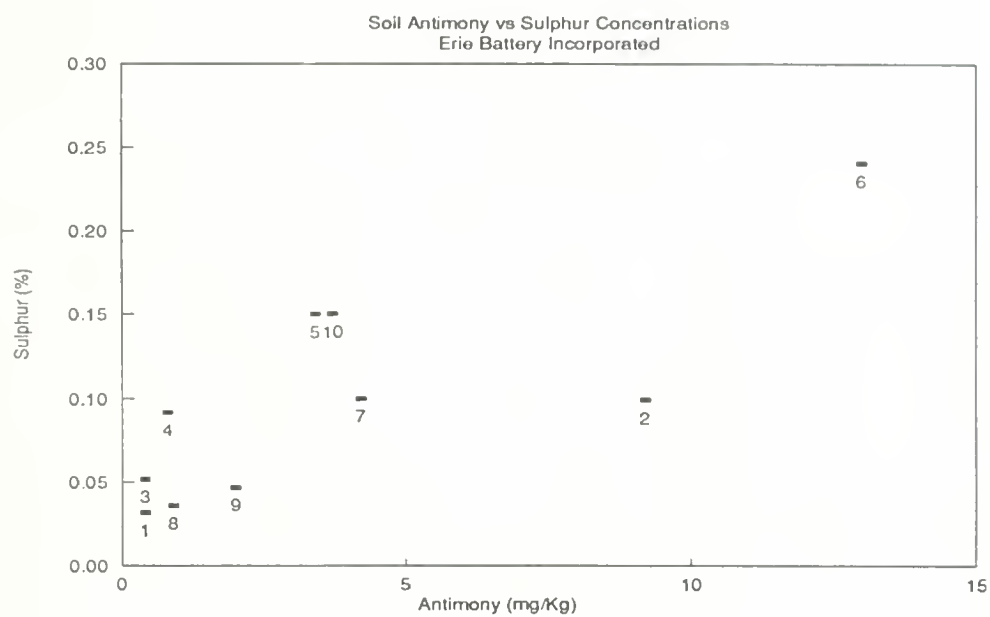
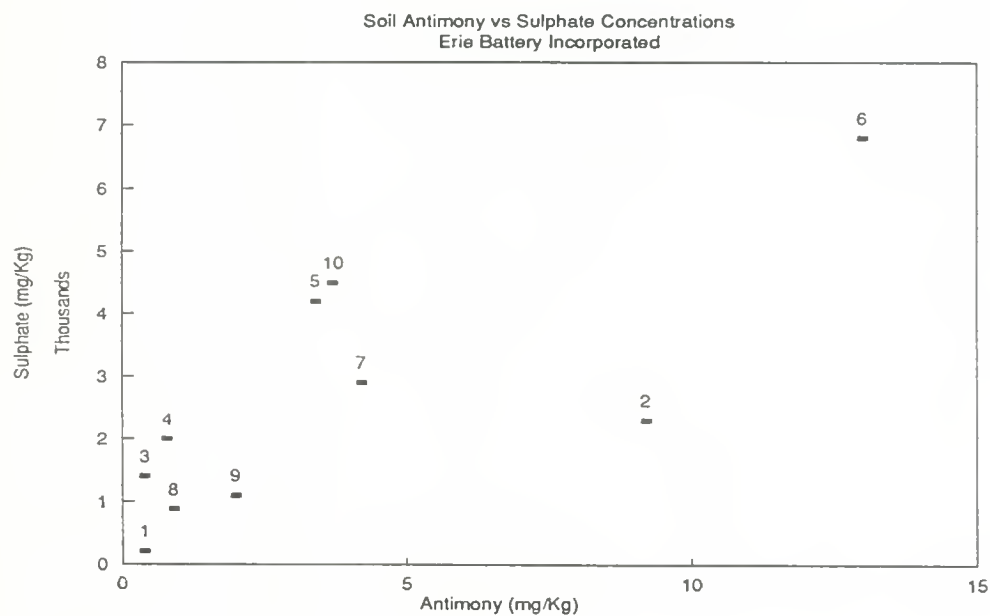
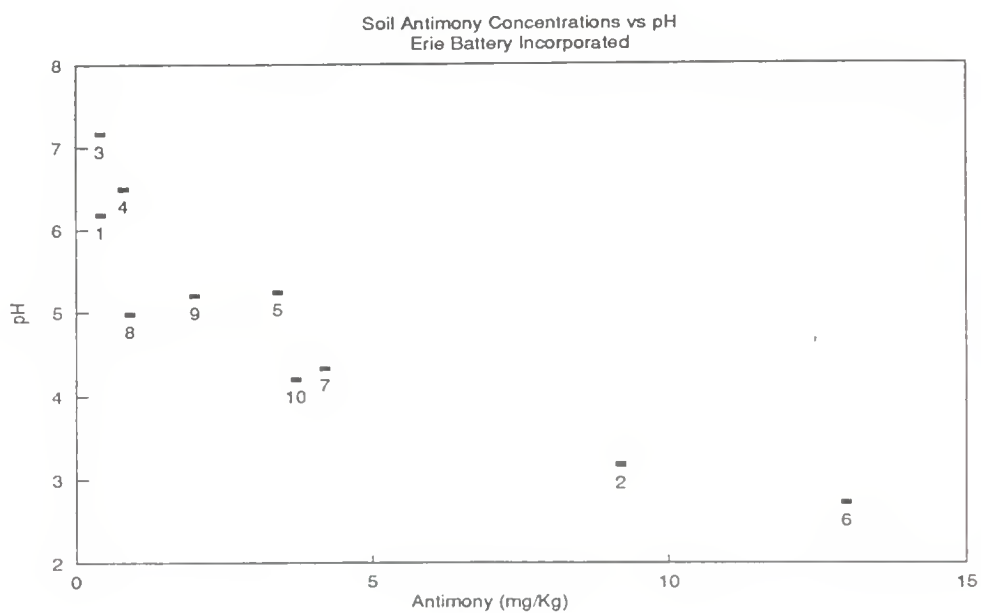
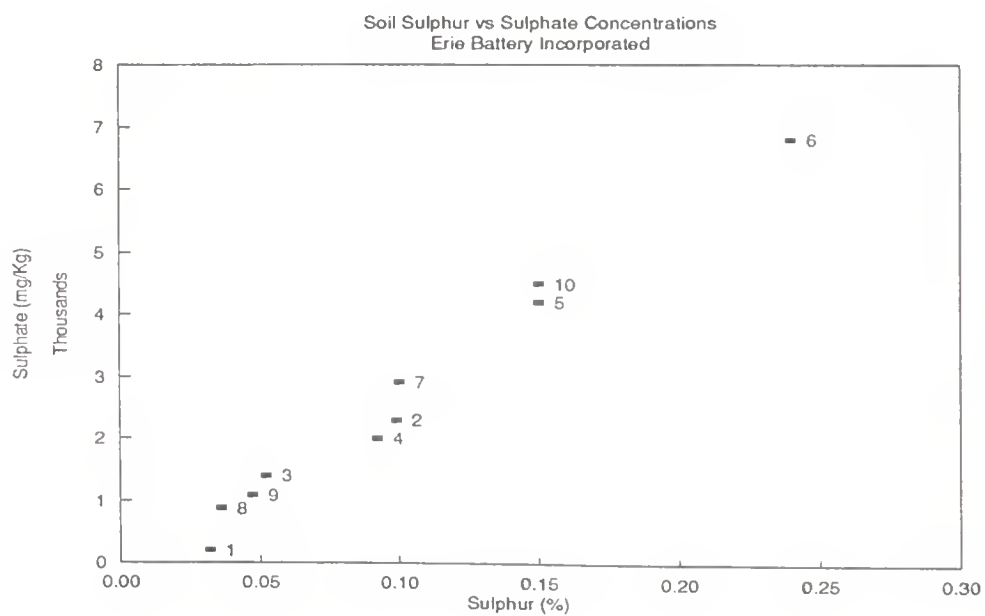
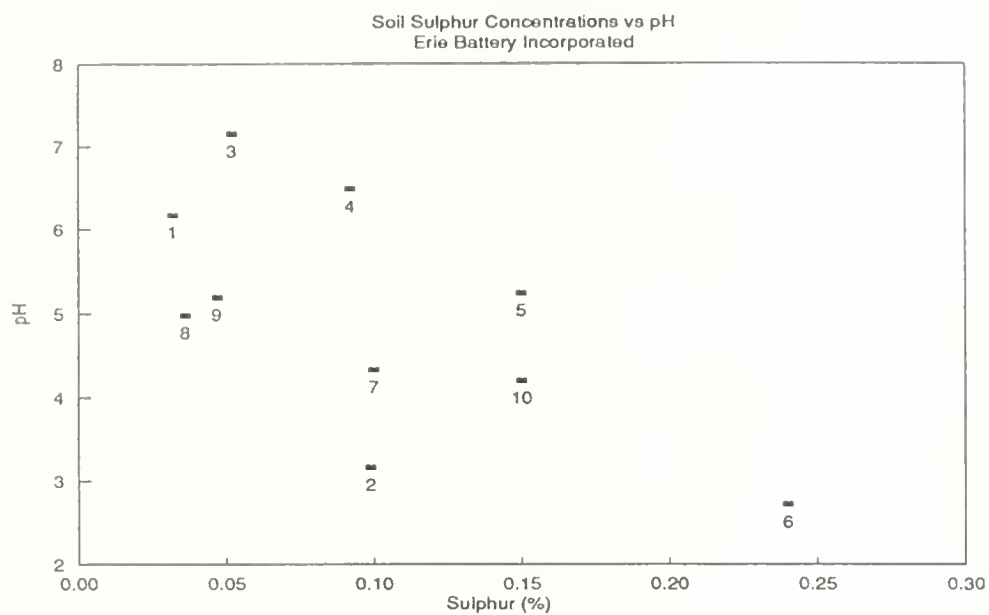
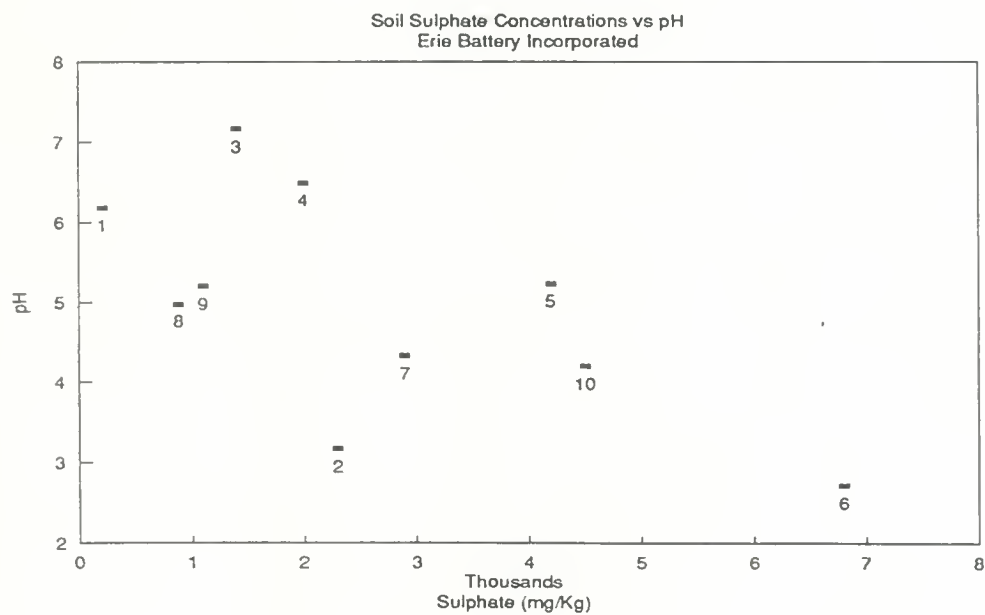
In order to demonstrate the relationships between the five analytes, a series of scatter plots were generated that would relate each pair of analytes. Ten such permutations are possible. Figures 2a through 2j represent the relationships between each pair.

A review of the ten scatter plots, Figures 2a through 2j, shows a tendency of Sites 1, 3, 4 and 8 to be clustered in the corner of the plots corresponding to the low contaminant concentrations or higher pH. Sites 1, 3 and 4, it should be recalled, were selected as sampling sites that were unlikely to have been influenced by the discharge of the solution from the loading dock. Site 8, on the other hand, was a site in the ditch, downhill from the alleged point of discharge.

At the other extreme, Site 6 consistently falls into the diametrically opposite corner of the plots, corresponding to high contaminant concentrations and acidified soil. Site 6 was selected as the site where discharge would have entered the ditch. The analytical data supports this scenario.

The remaining sites show intermediate degrees of contamination and acidification. Analytical data for these sites distinguish them as being distinct from those not influenced by the discharge. The irregular distributions shown by Sites 2, 5, 7, 9 and 10 suggest that variable amounts of residue were deposited by the discharge. This may be due to varying residence times (i.e. pooling) of the contaminating solution on the soil or differences in the affinity of the soil to adsorb the contaminants.

group of unaffected sites in the scatter plots, is a ditch site. This sample was moderately acidic, but the contaminant concentrations were quite low.
